Contract #: 04-0120F4Cty: SF/ALA Rte: 80 PM: 13.2/13.9File #: 1.28**WELDING INSPECTION REPORT****Resident Engineer:** Casey, William**Address:** 333 Burma Road**City:** Oakland, CA 94607**Report No:** WIR-030065**Date Inspected:** 18-Sep-2013**Project Name:** SAS Superstructure**OSM Arrival Time:** 700**Prime Contractor:** American Bridge/Fluor Enterprises, a JV**OSM Departure Time:** 1730**Contractor:** American Bridge/Fluor Enterprises, a JV**Location:** Job Site**CWI Name:** Bernie Docena, Tony Sherwood**CWI Present:** Yes No**Inspected CWI report:** Yes No N/A**Rod Oven in Use:** Yes No N/A**Electrode to specification:** Yes No N/A**Weld Procedures Followed:** Yes No N/A**Qualified Welders:** Yes No N/A**Verified Joint Fit-up:** Yes No N/A**Approved Drawings:** Yes No N/A**Approved WPS:** Yes No N/A**Delayed / Cancelled:** Yes No N/A**Bridge No:** 34-0006**Component:** SAS Tower**Summary of Items Observed:**

ESW Repair Excavation Welding

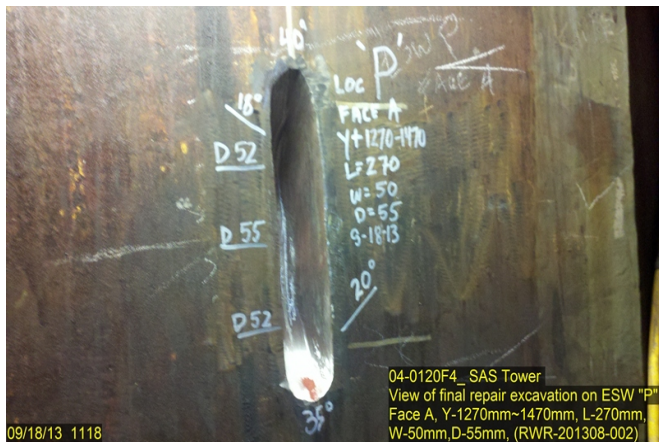
The QA Inspector observed ABF welder Donald Plumb (WID-0891) performing excavation of ESW "P" Face A @ Y-1330mm to verify indications observed during Ultrasonic Testing pulse/echo & pitch/catch. Mr. Plumb was performing the excavation using an air carbon arc gouging and a grinder. The welder was instructed by ABF QC Inspector Bernie Docena to notify him when indications are visible to allow QC/QA time to inspect the excavation.

Excavation Length (Y=1270mm~1470mm) L-270mm, W= 50mm, D= 55mm.

After grinding to bright metal the QC Inspector performed Magnetic Particle Testing (MT) testing of the excavation. The QC Inspector stated the excavation appears to be free of discontinuities and he would complete ABF daily inspection report and magnetic particle testing report to detail the findings. Mr. Docena b also stated that since the indication observed appeared to be a planar indication (centerline crack), the repair will be performed at both faces of the ESW weld at this Y location to remove the original ESW weld. The QA Inspector also performed MT inspection of the final excavation. After excavation Mr. Plumb was observed setting up to
